Technical Service Bulletin

Reference: ICOM-TSB15-002	Date: 5/8/2015
-------------------------------------	--------------------------

Vehicle Will Not Switch Over to Propane

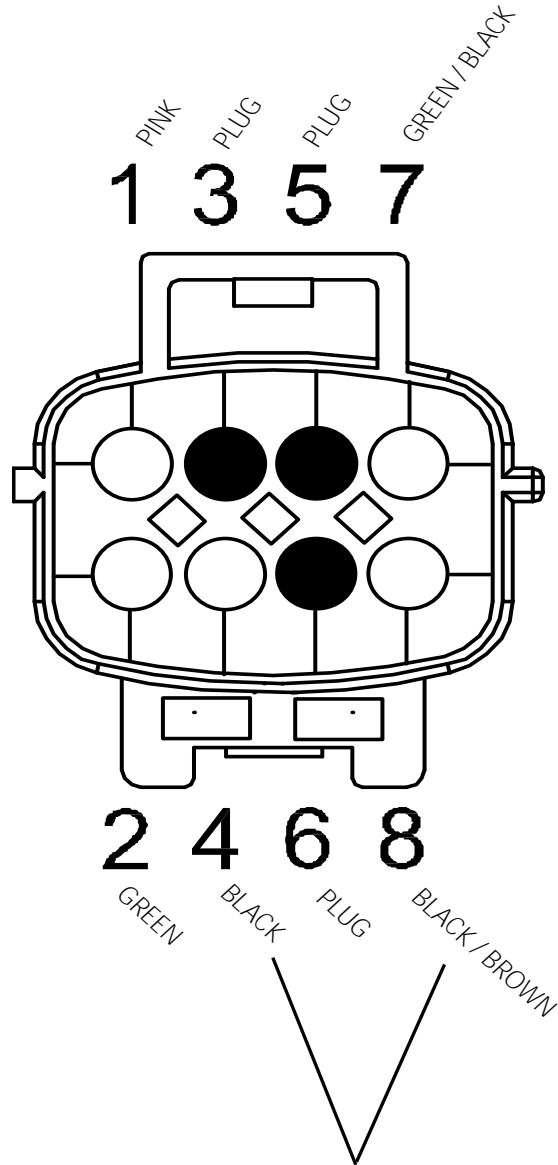
Verify that the black wire and the black/brown wire on the fuel tank wire harness are assembled into the 8-pin connector correctly (see Attachment 'A'). The black/brown wire is a 'switched ground' circuit and will cause a signal interruption to the supply pressure switch resulting in the 'beep out' condition.

WHEN LOOKING AT THE BACK OF THE FUEL TANK WIRE HARNESS CONNECTOR, VERIFY THAT THE BLACK WIRE IS ASSEMBLED INTO POSITION '4' AND THE BLACK WIRE WITH BROWN TRACER IS INSTALLED INTO POSITION '8' REPOSITION IF NECESSARY
